Number 1: 312 S. TALBOT STREET - LEONARD FUNERAL HOME

Number 4: 305 S. TALBOT STREET - THE MARYLAND NATIONAL BANK

Number 6: 101 N. TALBOT STREET - THE LAUNDROMAT

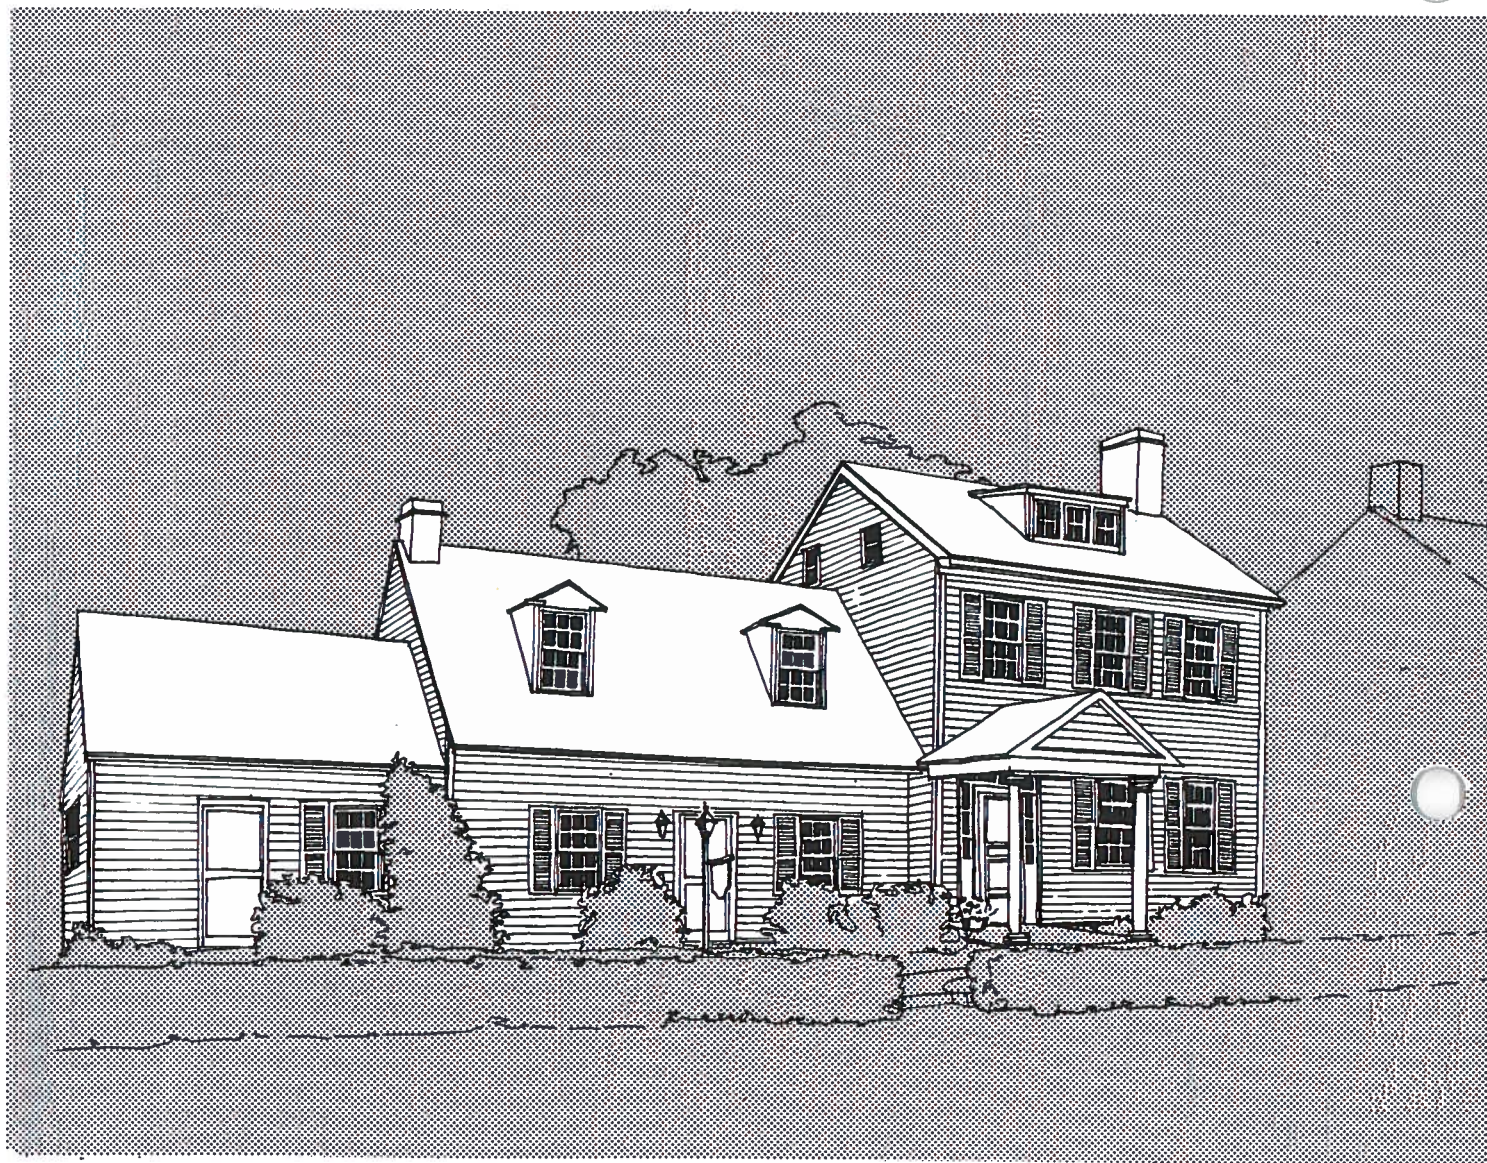
312 SOUTH TALBOT

1. This drawing shows the building as it appeared in 1987

A windowless, flush gabled end wall covers a masonry chimney at the north end of the house. The southern gable has two small windows at the attic level that flanked an exterior chimney in the past. This chimney has been removed.

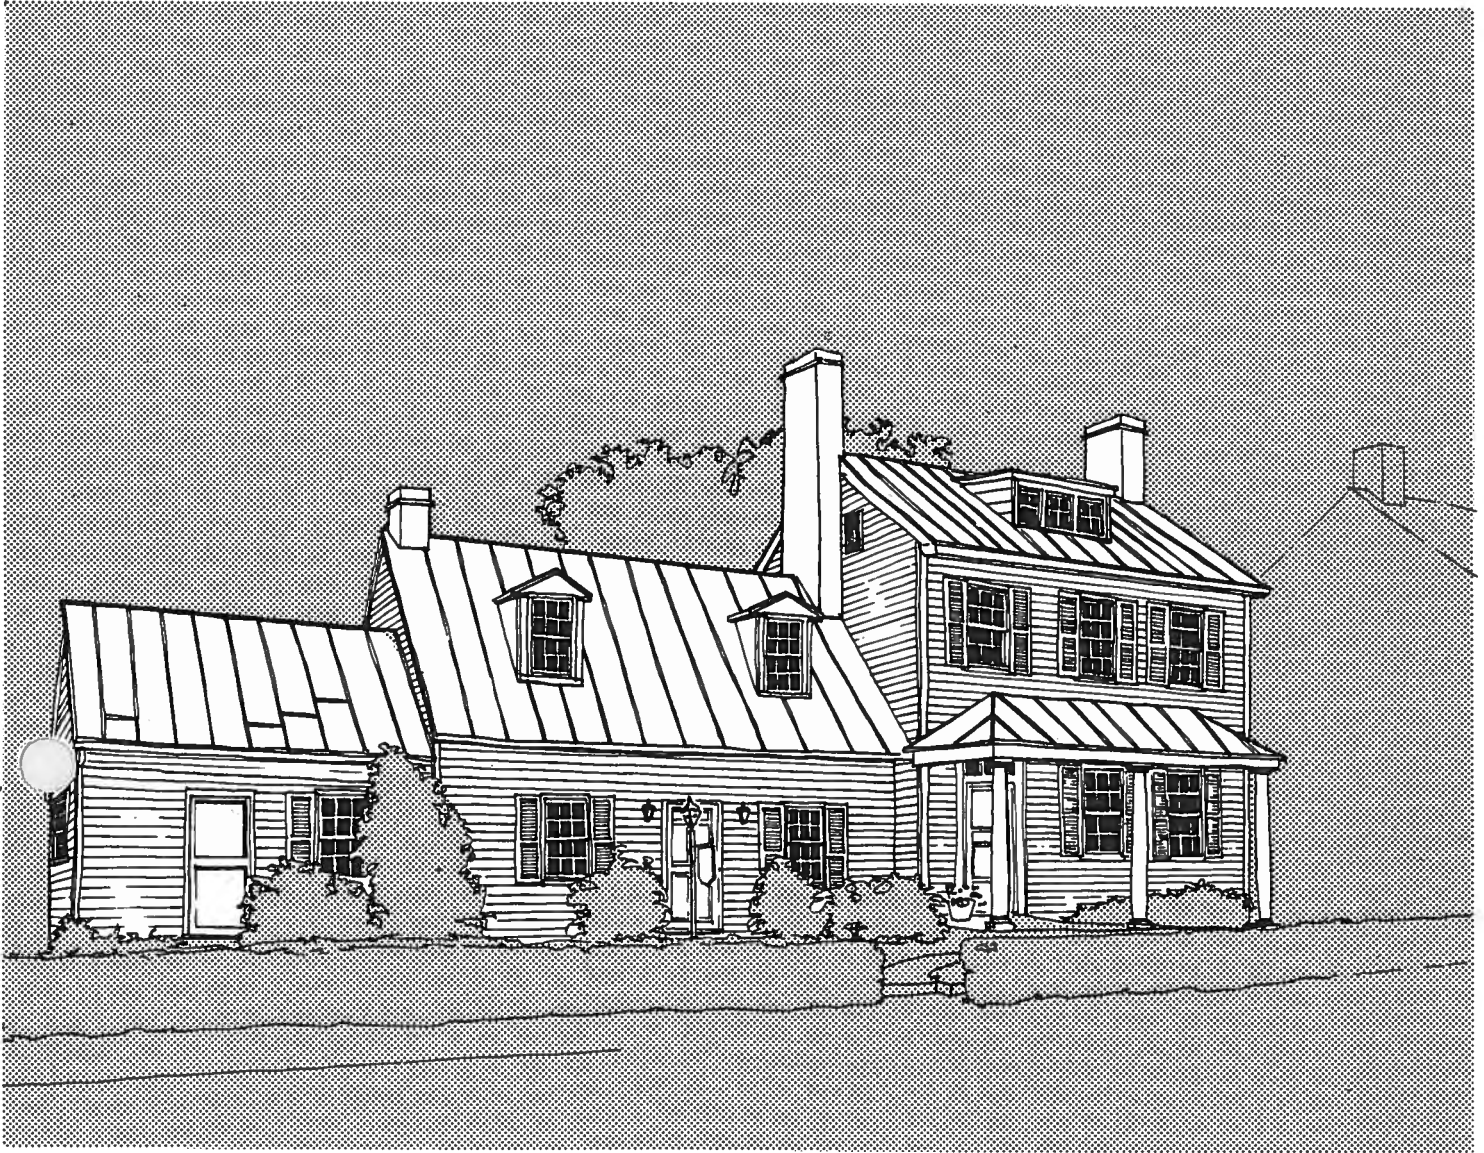
312 SOUTH TALBOT

1. This drawing shows the building as it appeared in an early photograph

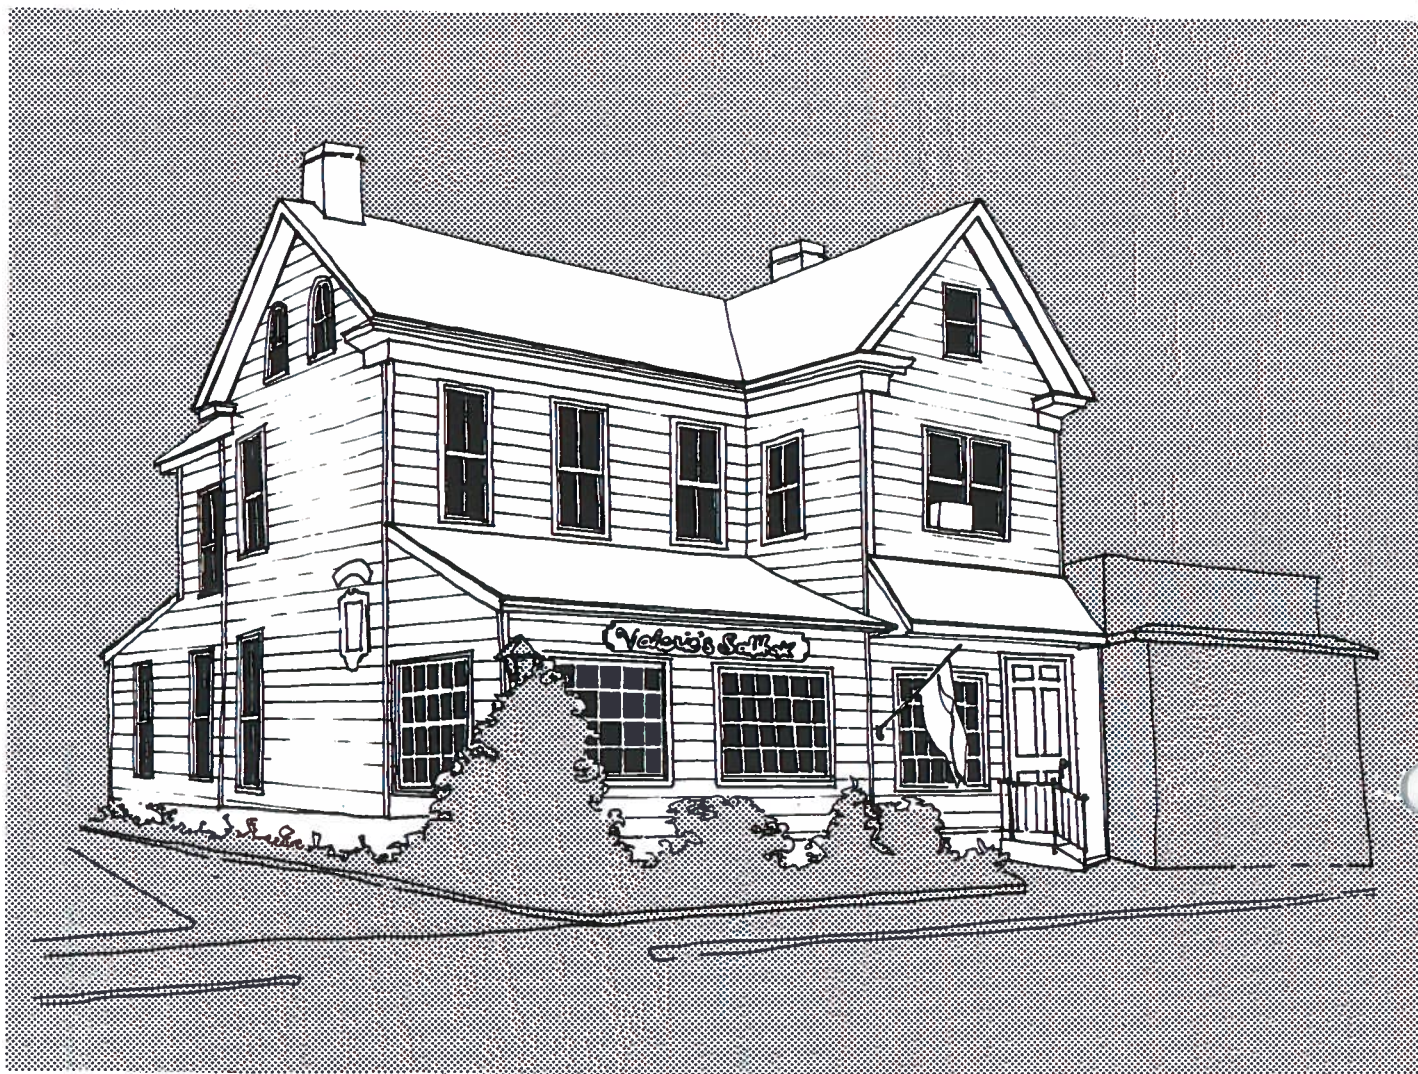
310 SOUTH TALBOT

This drawing shows the building as it appeared in 1987

In recent years a great deal has changed. The second floor gallery has been removed, the porch enclosed and a heavy mansard hood built over the shop entrance at the north side of the building. The projecting gable end has lost its arch top window and the original windows on the second floor have been replaced by a pair of windows with very different proportions. Large picture windows with colonial grids have replaced the windows on the first floor and new siding with a narrow corner trim has taken the place of the original weatherboard and cornerboards. The chimney caps and hood are gone.

Every effort should be made to preserve and maintain this house. The foundation and basic framing members should be checked and repaired if necessary. The wooden porch floor framing and decking could be also checked and repairs made where necessary.

Each of the building components, the doors, windows, siding, trim and masonry elements should be recorded, inspected, maintained and repaired as required.

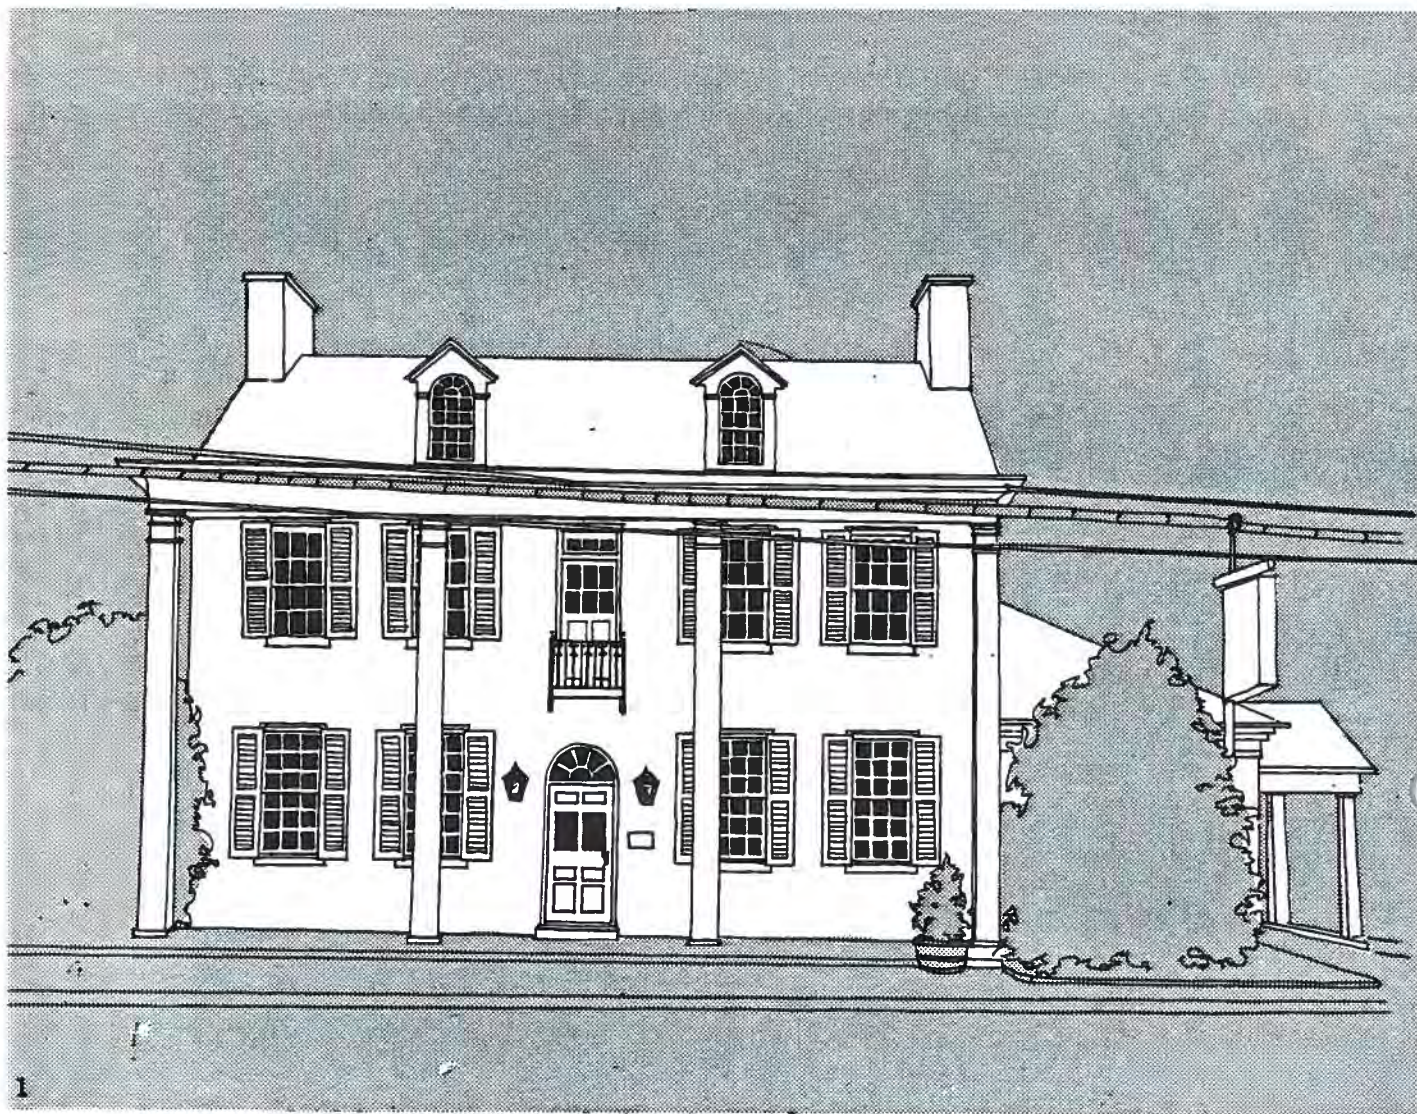
305 SOUTH TALBOT

1. This drawing shows the building as it appeared in 1987
2. This drawing shows the building as it may have appeared when first built
3. This drawing shows the building as it appeared in the early 1900's

was flaking and falling off. The original oak floor joists and rafters were rotted badly at their ends. The two-story front porch and gallery were unsafe.

Under Mr. Spencer's direction, the rotten floor joists and rafters were replaced and new frame walls were built to line the inside of the exterior walls to allow for insulation and a new wall surface. The interior walls were plaster over hand split oak lath. Most were in poor condition and were replaced.

He also removed the porches and replaced them with a two-story high portico supported on four square columns made from 6/4 cypress boards. During the remodeling much of the original pine flooring was found and reused as the floor of the bank manager's office. A mantel and some of the original interior woodwork was saved and incorporated in the bank interior.

The present configuration of the building seems to serve its purpose quite well. In the future, if desired and if good photographic evidence were found, the second floor gallery could be reconstructed. The early maps support the claim that the original building was built without a porch of any kind.

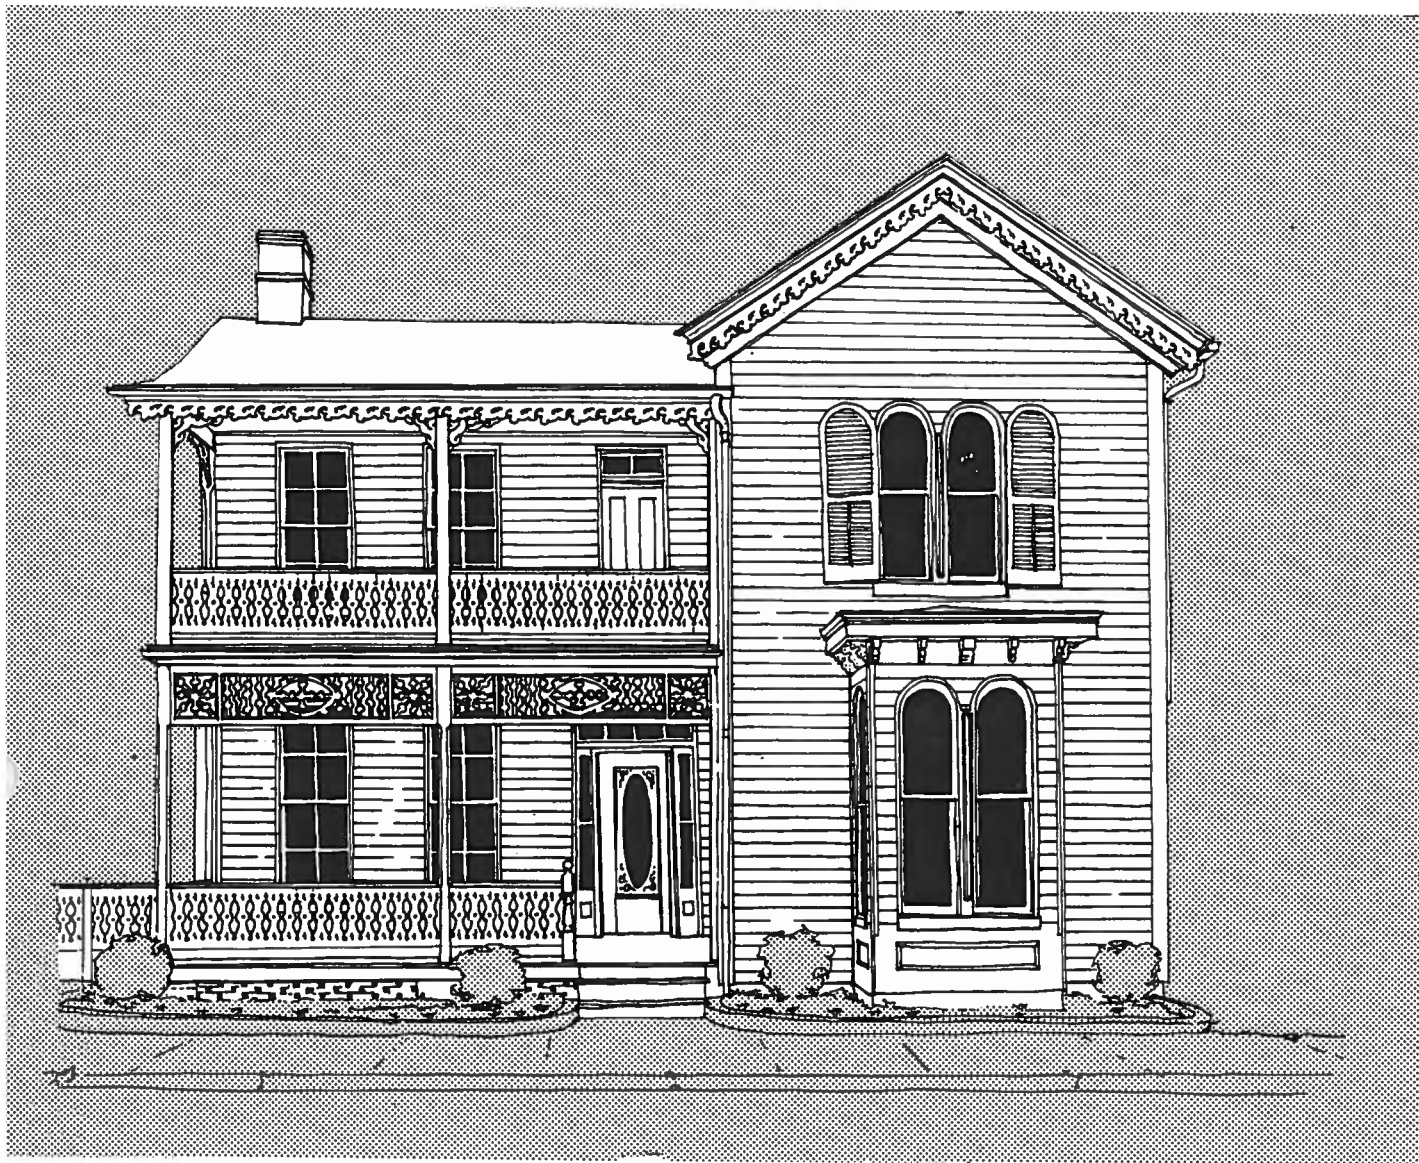
3 SOUTH TALBOT

is drawing shows the building as it appeared in 1987

The foundation conditions should be checked. Any problems encountered could be corrected.

The arched top shutters could be repaired.

When the house is repainted, a lighter color or white might be considered. The proportions and details of the house are outstanding. It does not need a contrasting color scheme to call attention to itself. More subtle colors might enhance the delicacy of the design and allow the play of light and shadow on the building's surfaces to be more greatly appreciated.

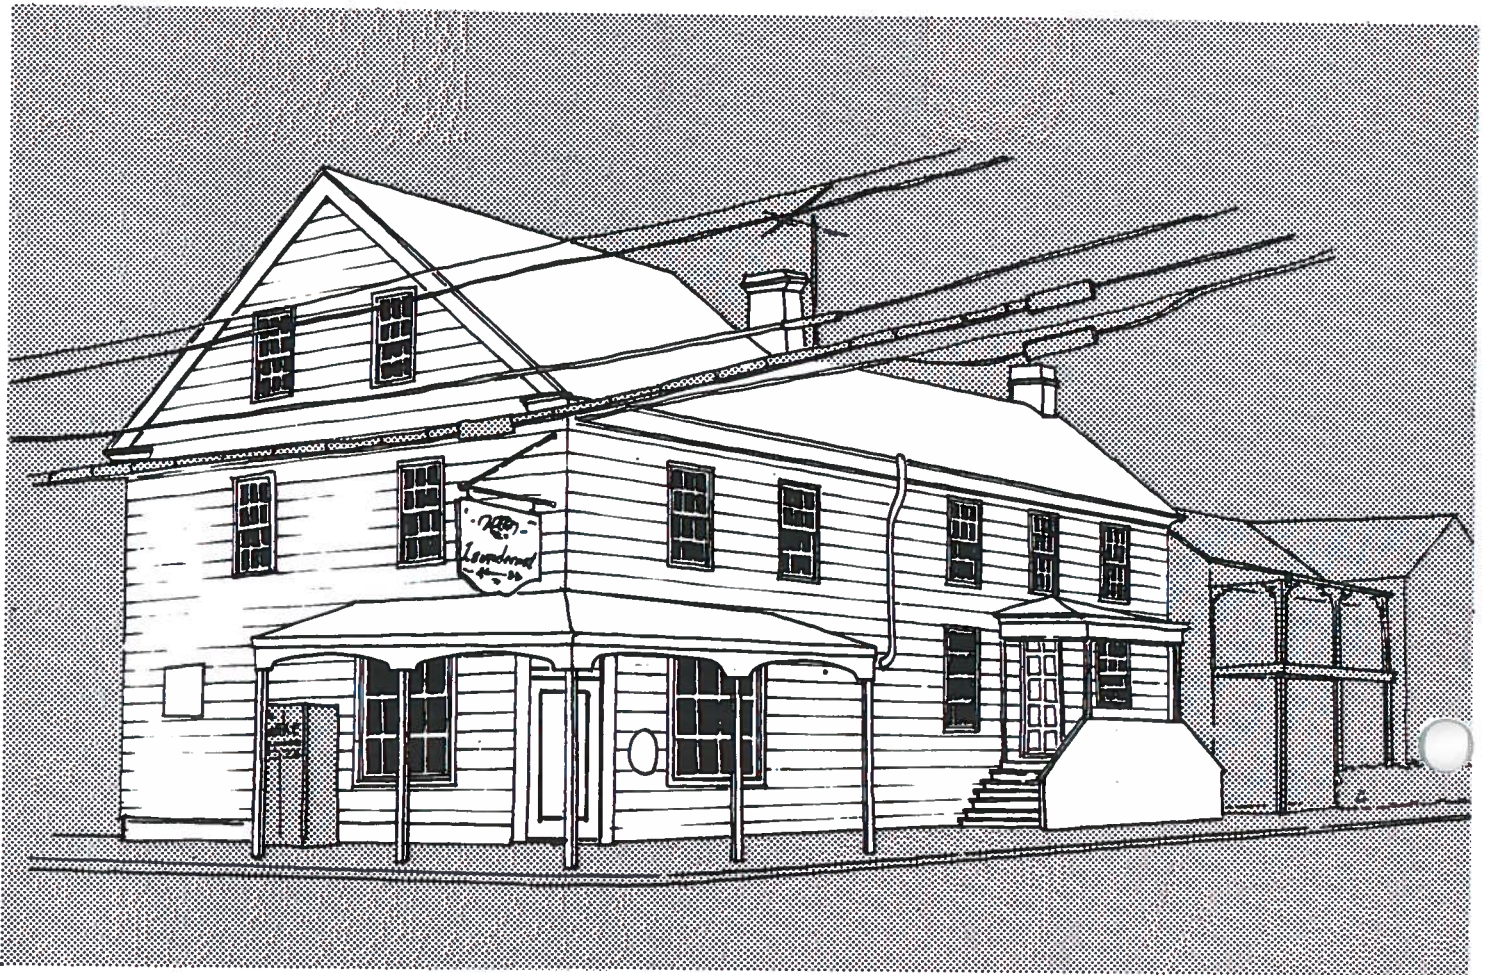
101 NORTH TALBOT

At the present time, the building has deteriorated considerably but provides an essential service to both the local community and visitors to the harbor.

This drawing shows the building as it appeared in 1987

This building is not in the best of condition. If possible a number of steps should be taken to insure its preservation. Its position and current use are important to St. Michaels.

The foundation could be checked and any necessary repairs done. The corner porch could be rebuilt to extend across the entire facade of the corner building on both Talbot and Cherry.

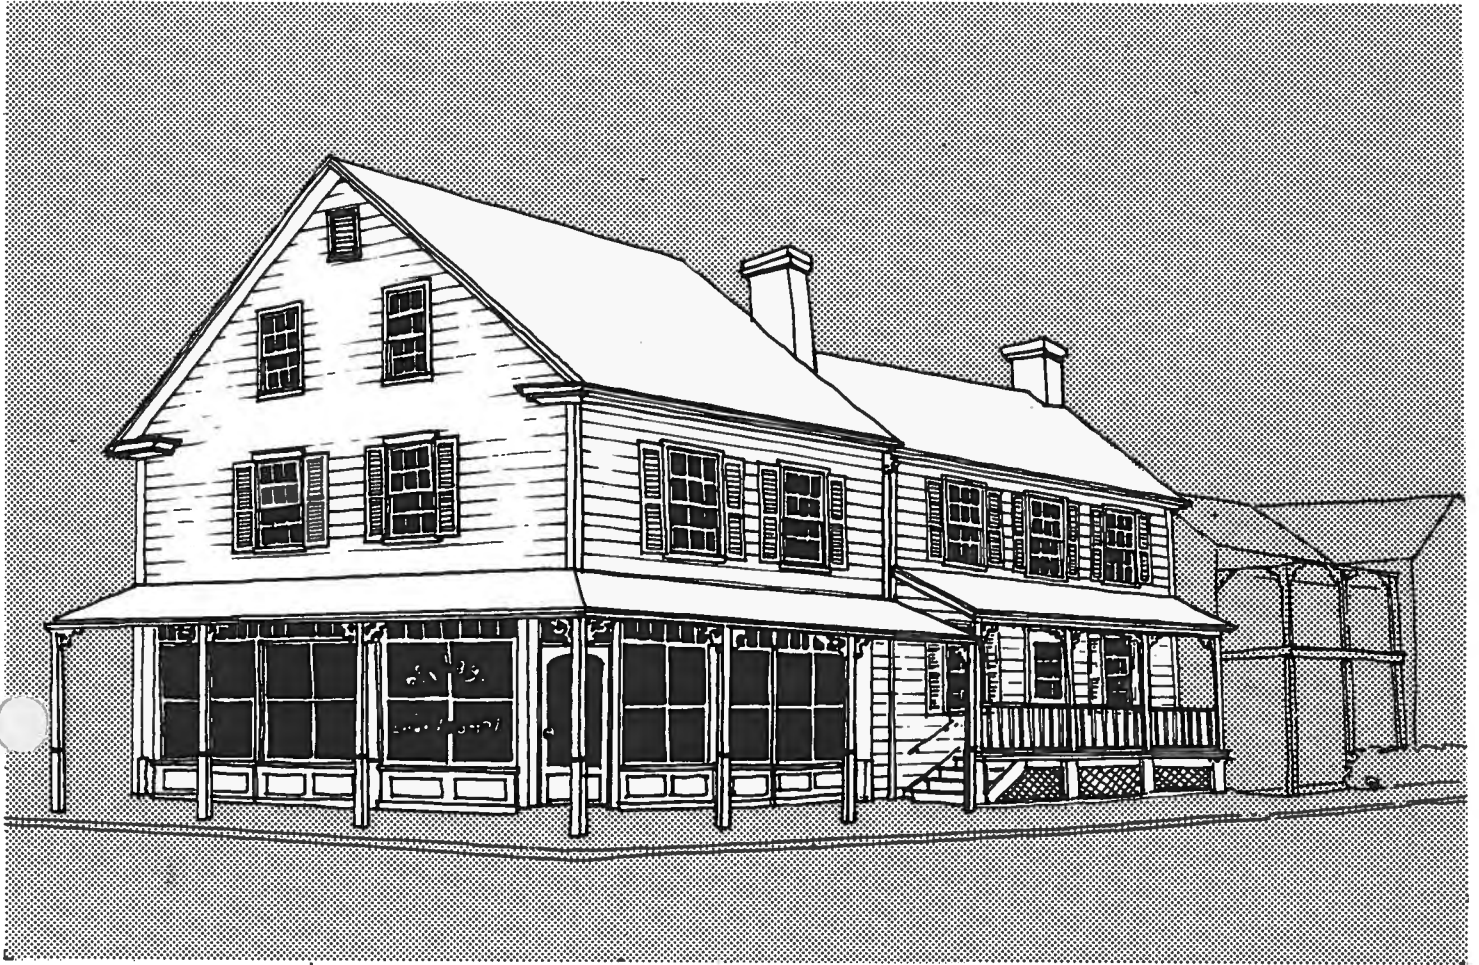
101 NORTH TALBOT

This drawing shows the building as it might appear if renovated

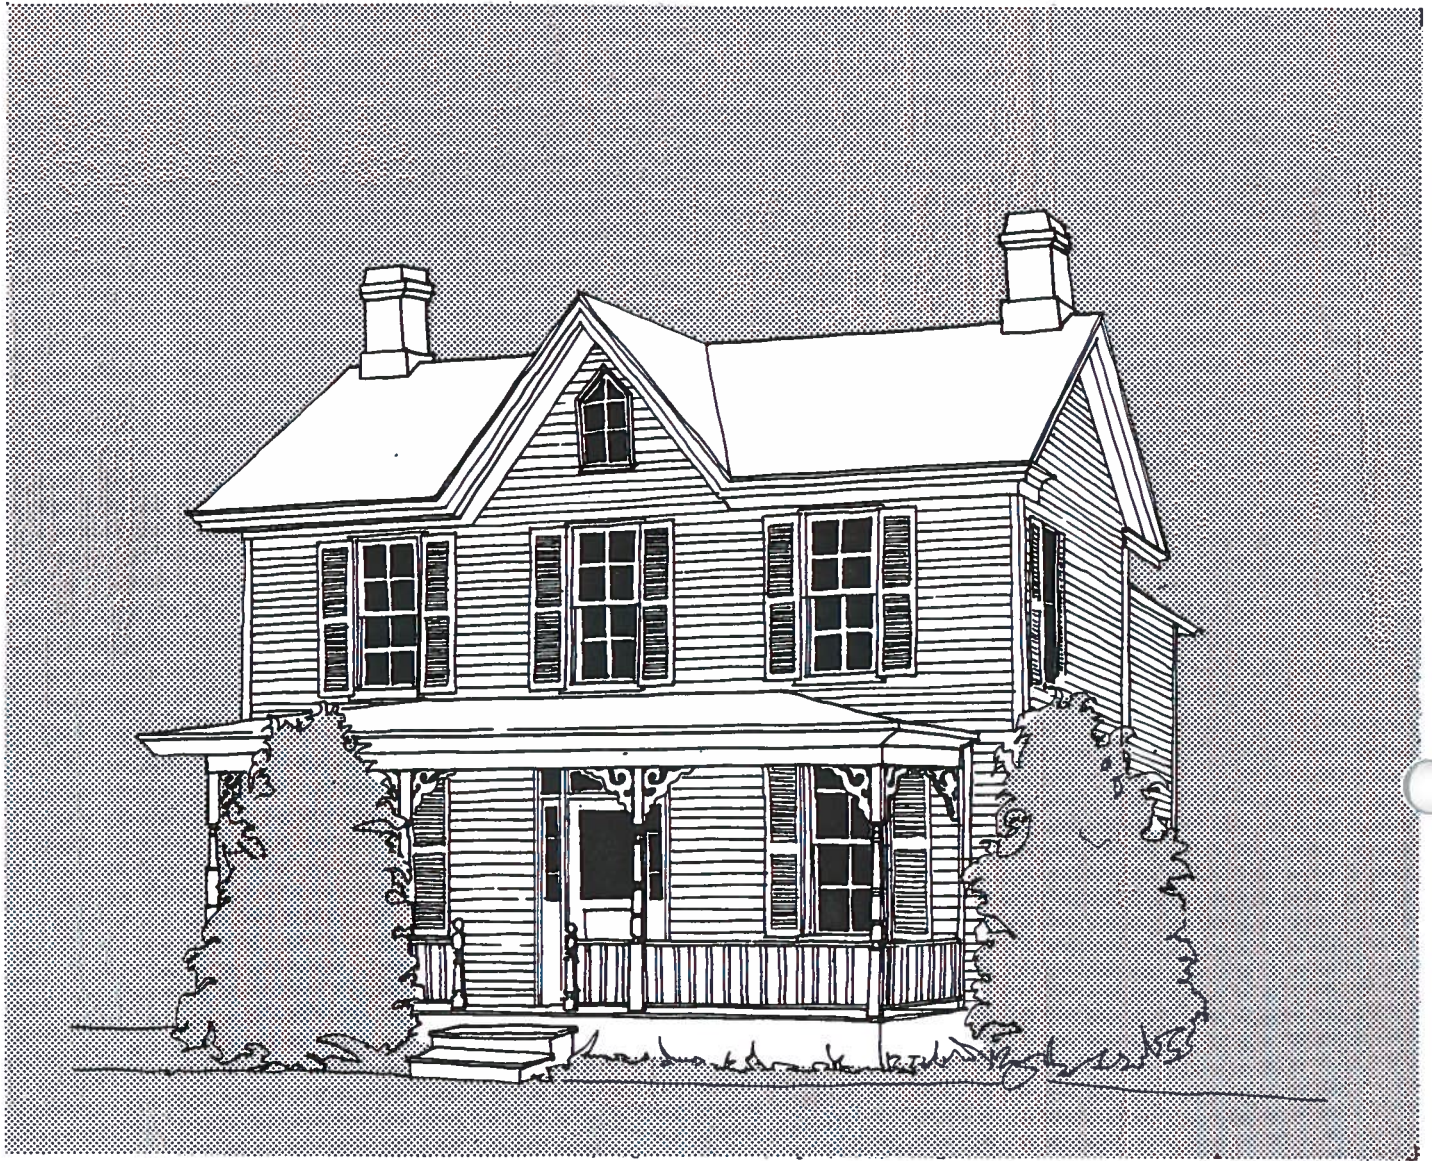
104 NORTH TALBOT

This drawing shows the building as it appeared in 1987

The foundations should be checked and any necessary repairs done. The windows, doors and porch elements could be inspected for deterioration. These parts of the house seem to be original and should be maintained and preserved. When required, the siding could be replaced with painted wood siding that closely matches the original. When required, the roof could be replaced by a seamed metal roof. The aluminum storm/screen door could be replaced by a storm/screen door with wood rails and stiles that would display the front door of the house. The air conditioner in the second floor window on the north side of the house could be relocated to a place where it is not easily seen from Talbot Street.

The sketch shows this house as it is today with a few minor repairs.

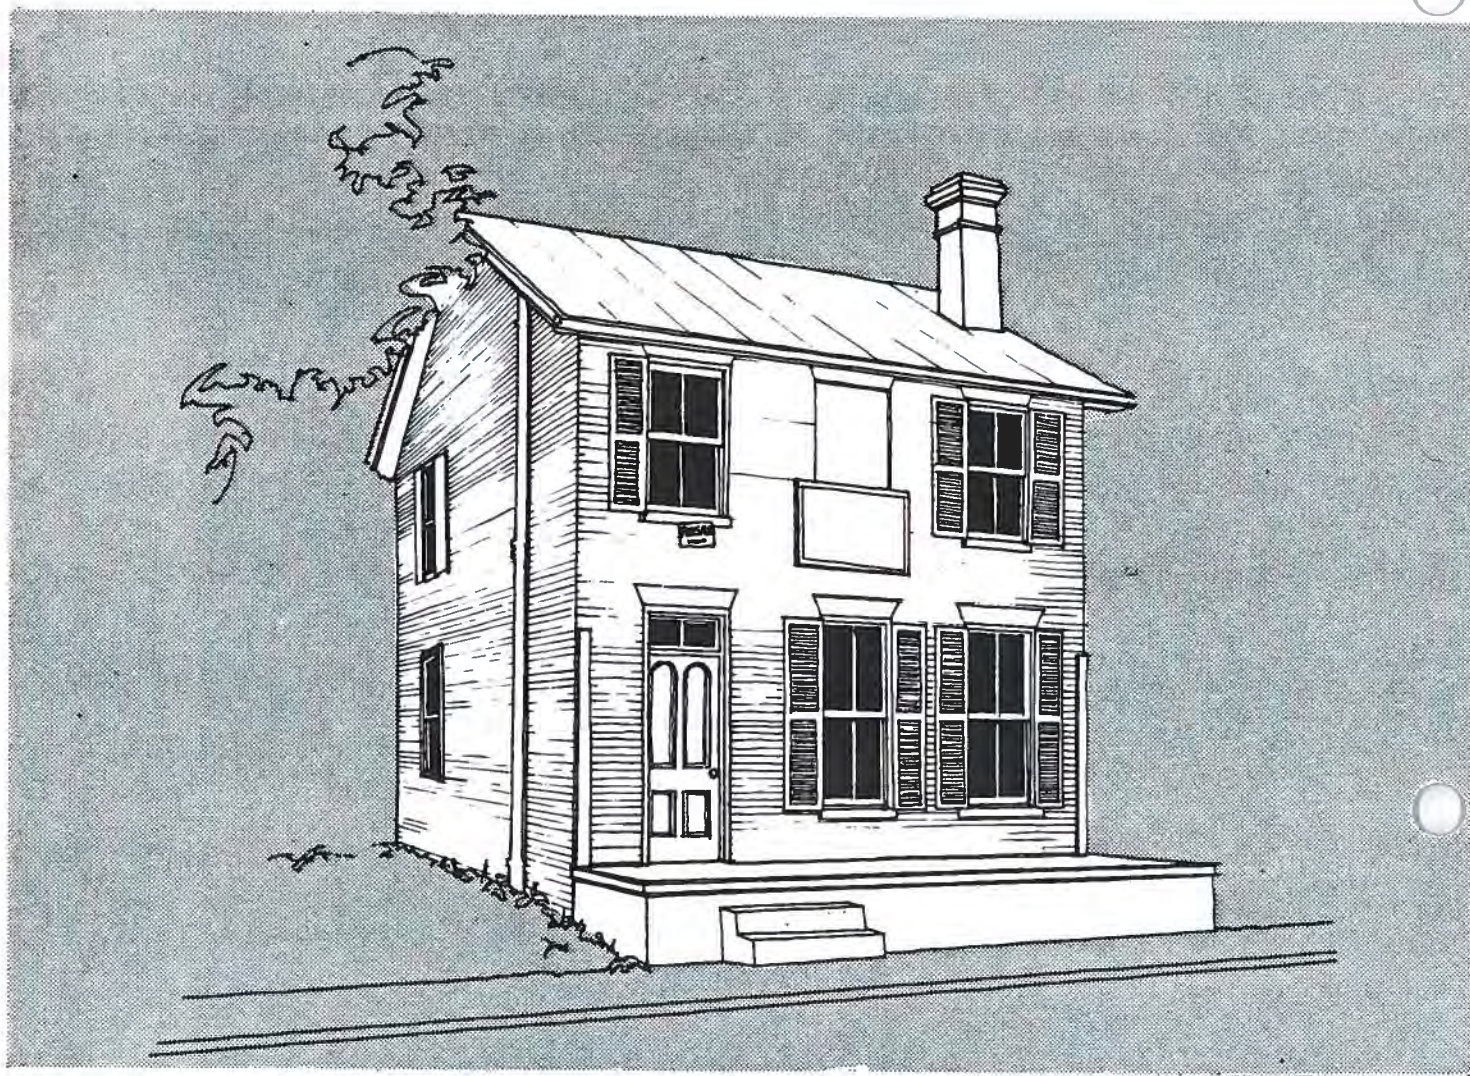
202 NORTH TALBOT

The brick walls of the house show signs of repair and change over the years. The pockets for the porch beams can be seen. A three course wide belt marks the second floor on the front of the house only. Single brick jack arches span the openings for the door and windows.

This drawing shows the building as it appeared in, 1987

The house should be repaired, maintained and preserved. The front porch and gallery should be reconstructed.

The foundation and floor structure should be checked and repaired as required.

The original windows and doors should be carefully preserved and repaired where required. The missing window or door could be built to match the original ones.

When required, the roofing could be replaced with shingles with a texture similar to those seen in the old photograph.

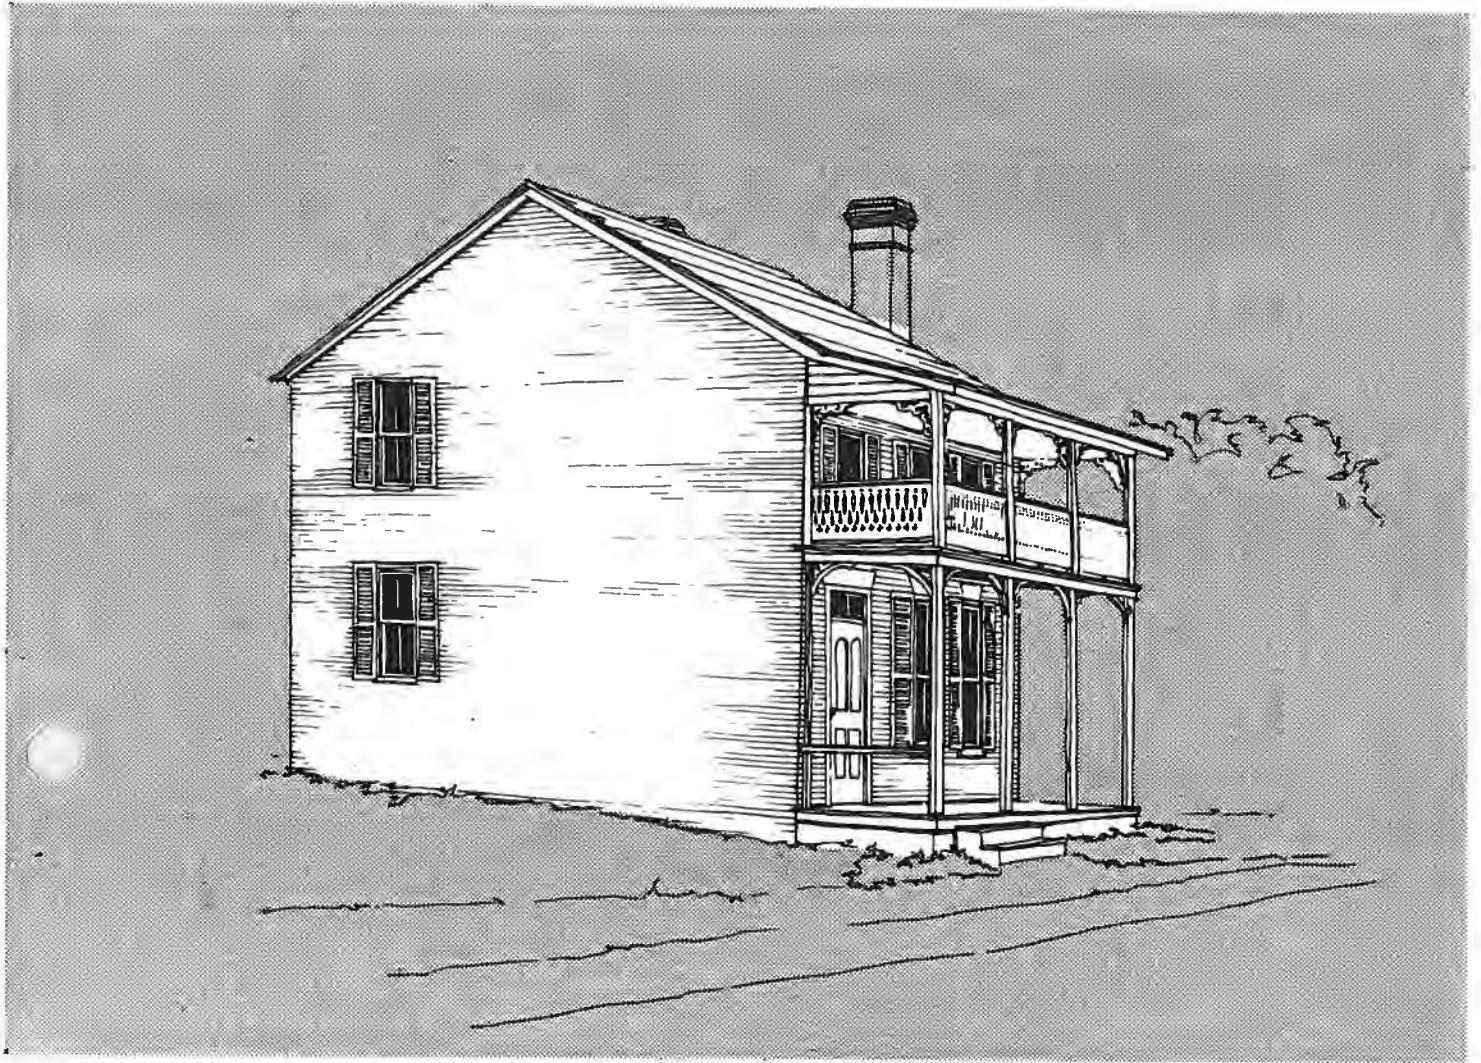
202 NORTH TALBOT

This drawing shows the building as it appeared in an early photograph

The sketches show this house as it is today and how it might be if it were repaired. This sketch is based upon the photograph provided by the Maritime Museum.
